# Cooks Creek – Update of Watershed Conservation Plan

# Project Funding

# Project Goal & Scope

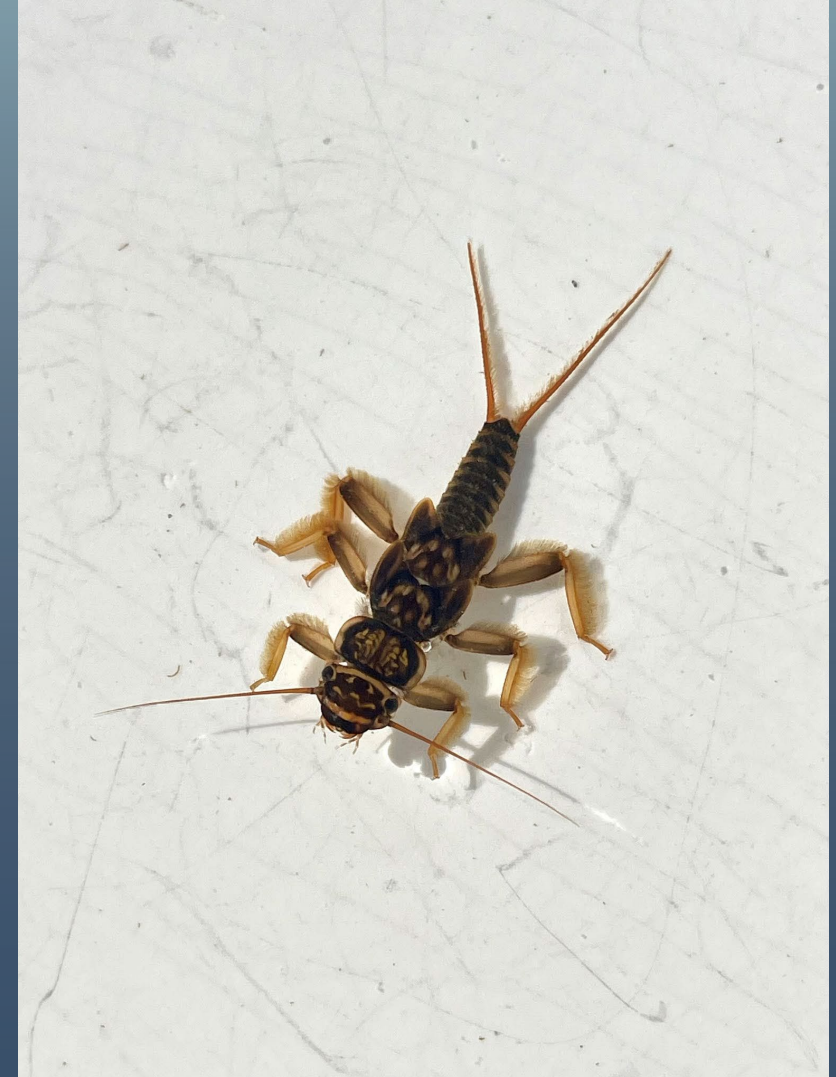
# Cooks Creek – State Designations

- ✓ PADEP Chapter 93  
Exceptional Value – Cold Water Fishery
  - Exceptional Value afforded highest degree of environmental protection in Pennsylvania
- ✓ PAFBC Class A Wild Trout Stream
  - Support population of naturally produced trout to support and long-term and rewarding sport fishery

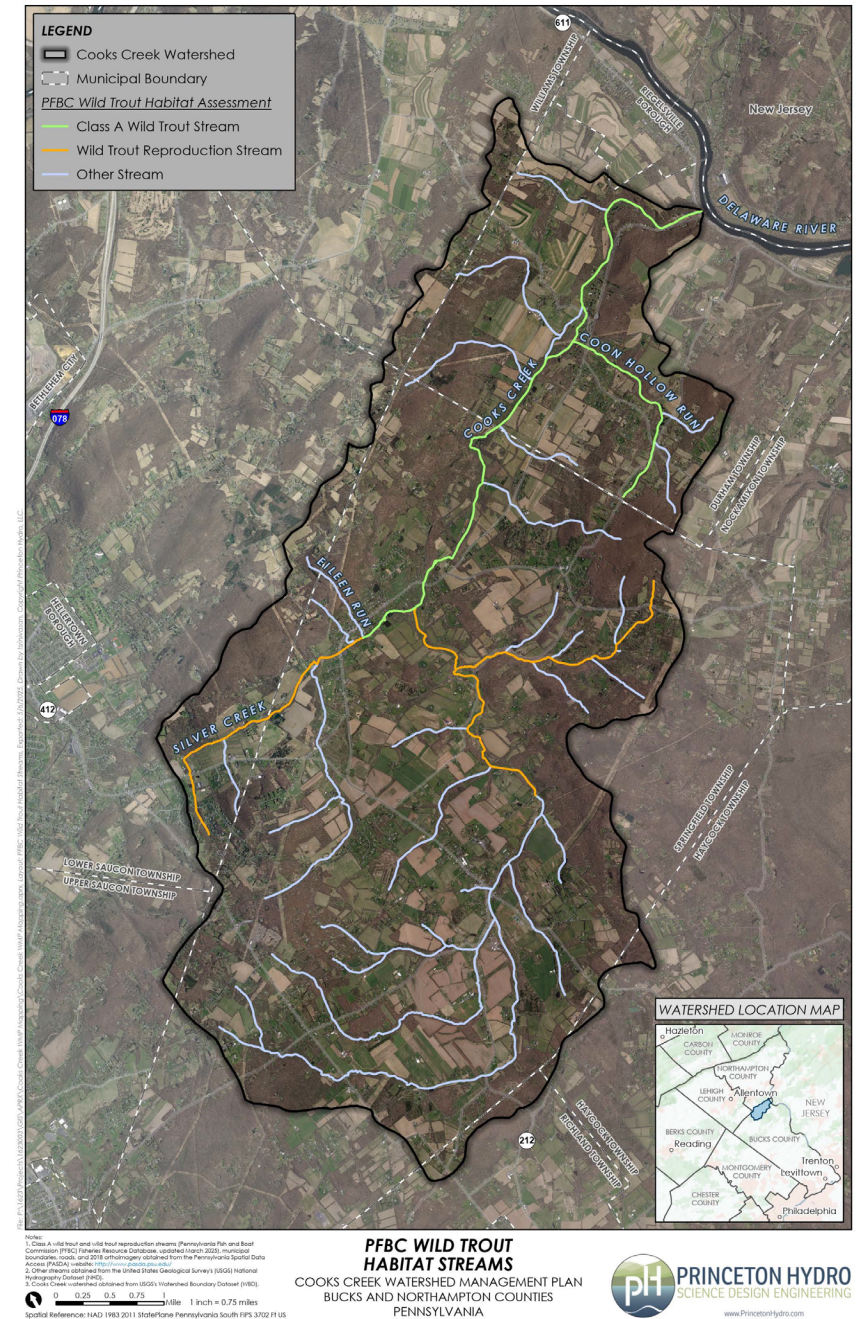
# Class A Wild Trout Stream

PFBC Wild Trout Reproduction Streams 16.47 linear miles

PFBC Class A Wild Trout Streams 8.42 linear miles

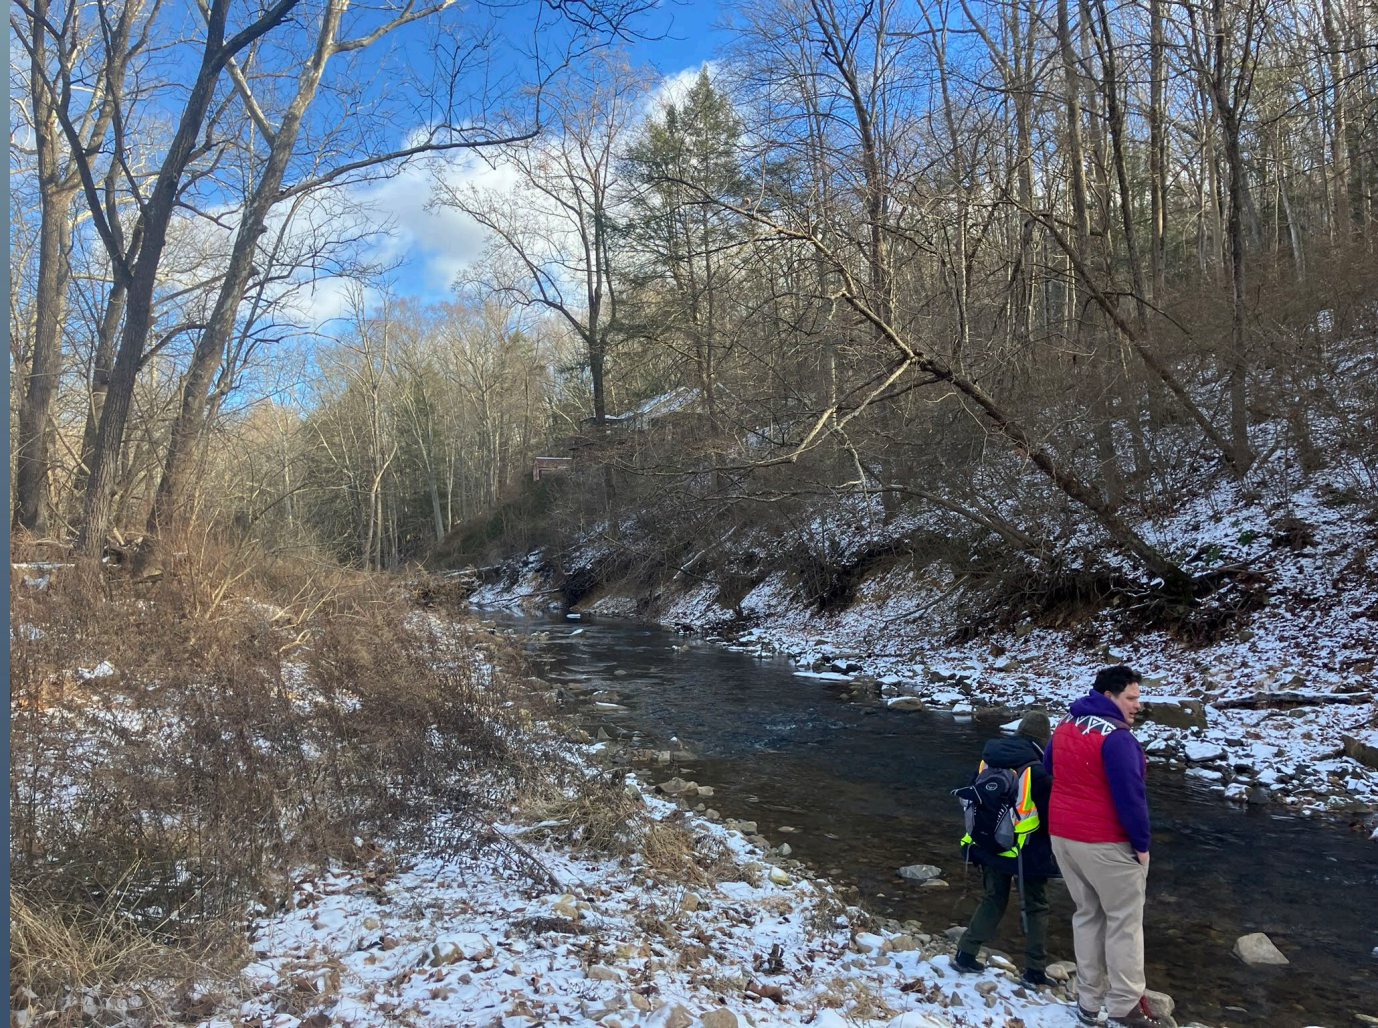
- ✓ Conducted over two days in January 2024
- ✓ Princeton Hydro engineers and fluvial geomorphologists
- ✓ Representatives from the CCWA and townships
